**VILLAGE OF ANTIOCH, ILLINOIS  
ROUTE 83 & DOWNTOWN CORRIDOR STUDY**

**HISTORIC SURVEY**

**SURVEY FORMS:  
DOWNTOWN DISTRICT  
& SELECTED PROPERTIES**

**GRANACKI**  
HISTORIC CONSULTANTS

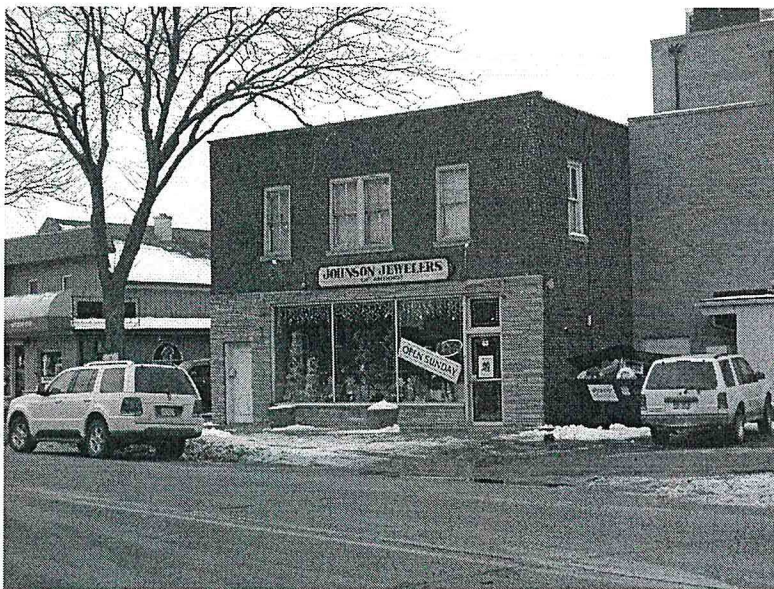
CATEGORY	<input type="text" value="building"/>	CURRENT FUNCTION	<input type="text" value="Commerce/Trade - business"/>
CONDITION	<input type="text" value="fair"/>	HISTORIC FUNCTION	<input type="text" value="Domestic - single dwelling"/>
INTEGRITY	<input type="text" value="major alterations and/or addition(s)"/>	REASON for SIGNIFICANCE	<input type="text"/>
STOREFRONT INTEGRITY	<input type="text" value="major alterations"/>		
SECONDARY STRUCTURE	<input type="text"/>

Entire storefront has been replaced with non-historic materials (1950s) including artificial stone cladding, large plate glass display windows, and aluminum door and transom; replacement 2nd floor entry door

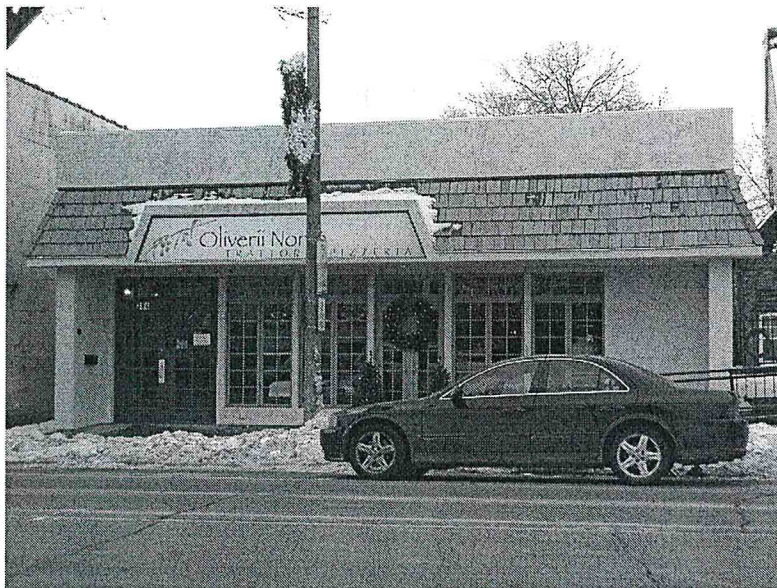
CATEGORY	<input type="text" value="building"/>	CURRENT FUNCTION	<input type="text" value="Commerce/Trade - restaurant"/>
CONDITION	<input type="text" value="excellent"/>	HISTORIC FUNCTION	<input type="text" value="Commerce/Trade"/>
INTEGRITY	<input type="text" value="major alterations and/or addition(s)"/>	REASON for SIGNIFICANCE	<input type="text"/>
STOREFRONT INTEGRITY	<input type="text" value="major alterations"/>		
SECONDARY STRUCTURE	<input type="text"/>

Cedar shake canopy over entire storefront; stucco cladding; all metal replacement windows and doors with multilight configuration

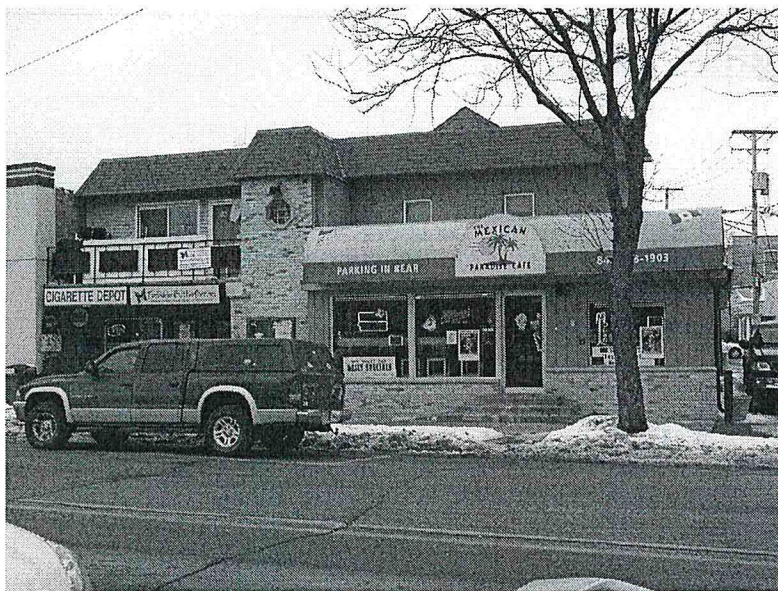
CATEGORY	<input type="text" value="building"/>	CURRENT FUNCTION	<input type="text" value="Commerce/Trade - business; Domestic - multiple dwe"/>
CONDITION	<input type="text" value="good"/>	HISTORIC FUNCTION	<input type="text" value="Commerce/Trade - business; Domestic - multiple dwe"/>
INTEGRITY	<input type="text" value="minor alterations"/>	REASON for SIGNIFICANCE	<input type="text"/>
STOREFRONT INTEGRITY	<input type="text" value="not altered"/>		
SECONDARY STRUCTURE	<input type="text"/>

Backlit canopy over east storefront covering 2nd floor balcony; replacement aluminum door on east storefront

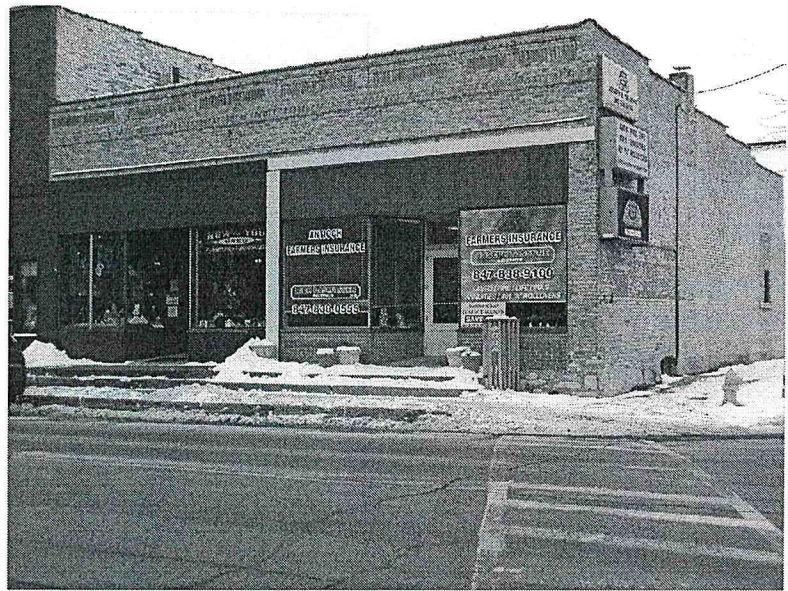
CATEGORY	<input type="text" value="building"/>	CURRENT FUNCTION	<input type="text" value="Commerce/Trade"/>
CONDITION	<input type="text" value="good"/>	HISTORIC FUNCTION	<input type="text" value="Commerce/Trade"/>
INTEGRITY	<input type="text" value="minor alterations"/>	REASON for SIGNIFICANCE	<input type="text"/>
STOREFRONT INTEGRITY	<input type="text" value="Minor alterations"/>		
SECONDARY STRUCTURE	<input type="text"/>

Brick on east storefront bulkhead has been painted; some windows replaced; vertical wood siding above storefronts on both sides

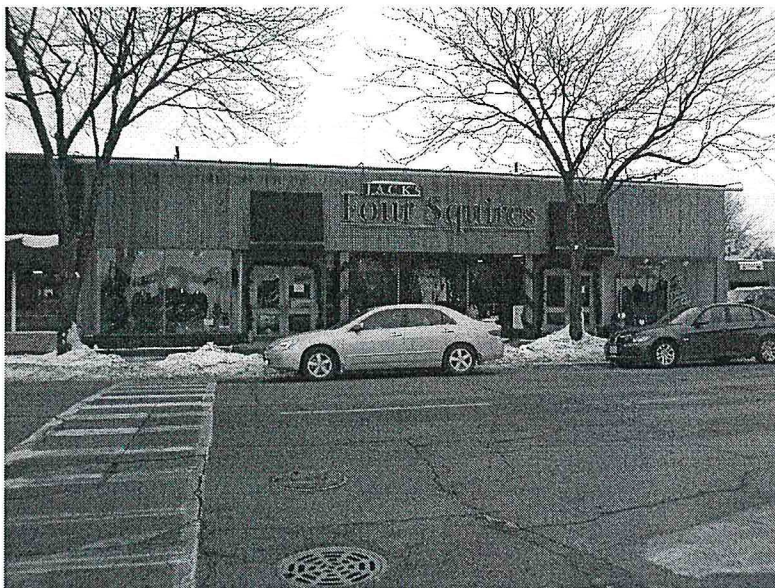
CATEGORY	<input type="text" value="building"/>	CURRENT FUNCTION	<input type="text" value="Commerce/Trade - business"/>
CONDITION	<input type="text" value="excellent"/>	HISTORIC FUNCTION	<input type="text" value="Commerce/Trade - business"/>
INTEGRITY	<input type="text" value="major alterations and/or addition(s)"/>	REASON for SIGNIFICANCE	<input type="text"/>
STOREFRONT INTEGRITY	<input type="text" value="major alterations"/>		
SECONDARY STRUCTURE	<input type="text"/>

Replacement windows; replacement doors in downsized openings; vertical wood siding; tile bulkhead

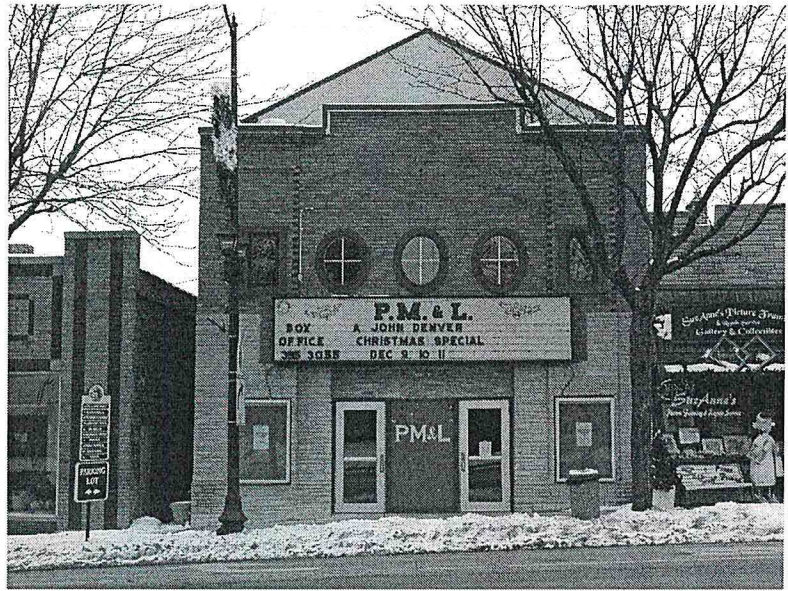
CATEGORY	<input type="text" value="building"/>	CURRENT FUNCTION	<input type="text" value="Recreation and Culture - theater"/>
CONDITION	<input type="text" value="fair"/>	HISTORIC FUNCTION	<input type="text" value="Recreation and Culture - theater"/>
INTEGRITY	<input type="text" value="major alterations and/or addition(s)"/>	REASON for SIGNIFICANCE	<input type="text" value="Historically significant, but lacking in architectural integrity."/>
STOREFRONT INTEGRITY	<input type="text" value="major alterations"/>		
SECONDARY STRUCTURE	<input type="text"/>

Entire storefront has been reconfigured and refaced with artificial stone; aluminum doors; replacement marquee

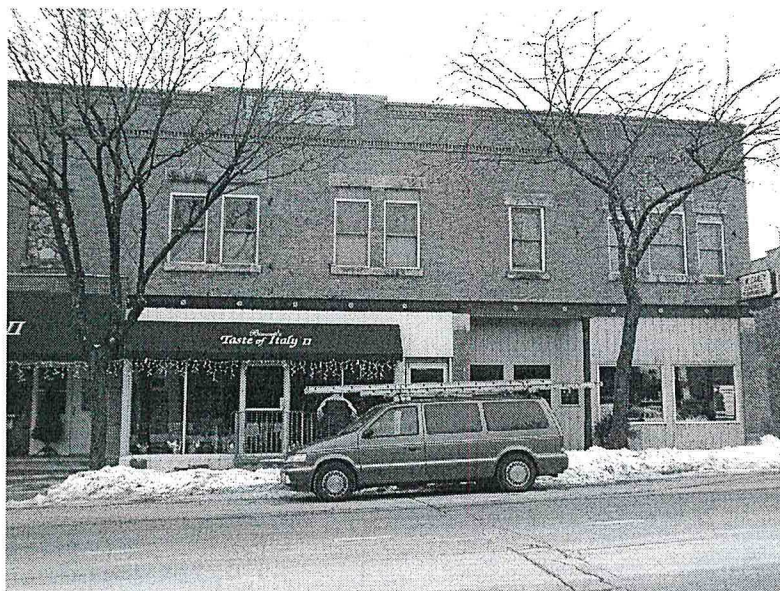
CATEGORY	<input type="text" value="building"/>	CURRENT FUNCTION	<input type="text" value="Commerce/Trade - business"/>
CONDITION	<input type="text" value="good"/>	HISTORIC FUNCTION	<input type="text" value="Commerce/Trade"/>
INTEGRITY	<input type="text" value="minor alterations and addition(s)"/>	REASON for SIGNIFICANCE	<input type="text"/>
STOREFRONT INTEGRITY	<input type="text" value="major alterations"/>		
SECONDARY STRUCTURE	<input type="text"/>

Storefronts and second floor entries have been reconfigured with mostly non-historic replacement materials including wood vertical board cladding, plate glass display windows, and aluminum entry doors
