**VILLAGE OF ANTIOCH, ILLINOIS  
ROUTE 83 & DOWNTOWN CORRIDOR STUDY**

**HISTORIC SURVEY**

**SURVEY FORMS:  
DOWNTOWN DISTRICT  
& SELECTED PROPERTIES**

**GRANACKI**  
HISTORIC CONSULTANTS

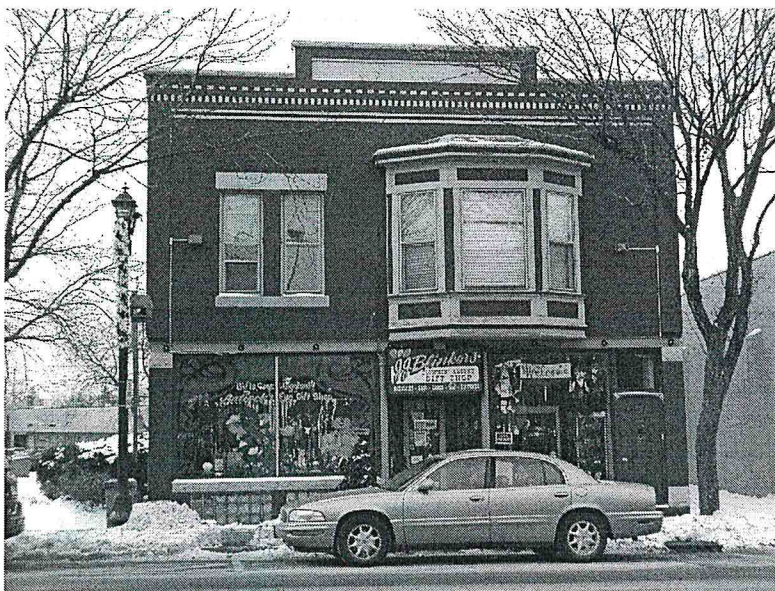
Replacement plate glass windows; replacement front door; replacement door to 2nd story; replacement transom over 2nd story entrance

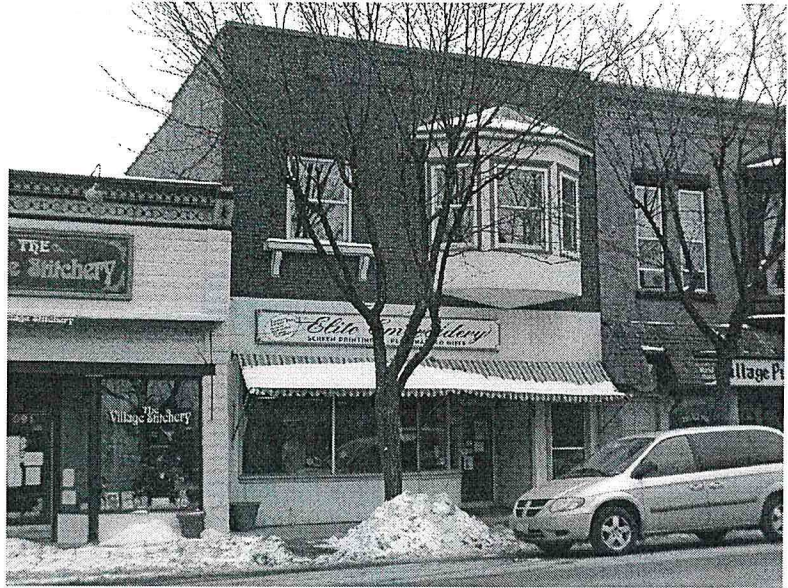
Entire storefront has been reconfigured with non-historic replacement materials including wood vertical board signboard, bulkhead, transom, and surround, shortened plate glass display windows; and aluminum entry door

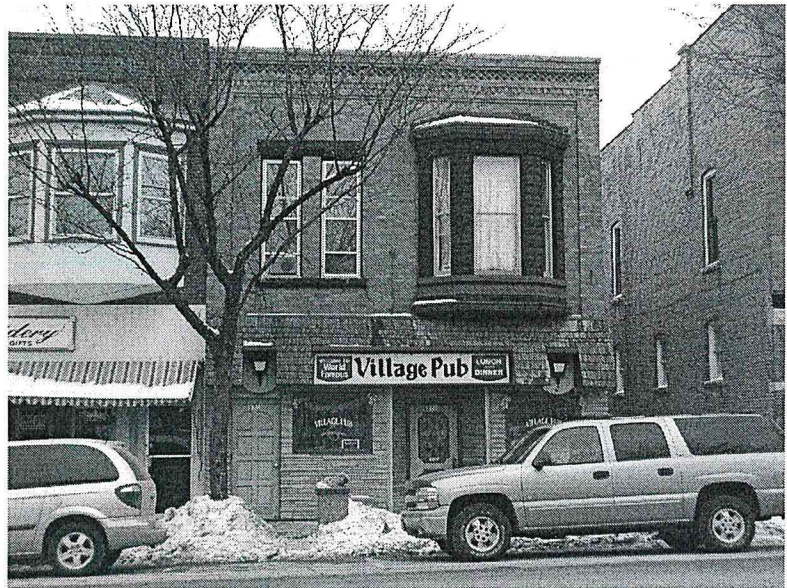
All non-historic replacement materials including entry doors, artificial stone cladding and downsized display windows, cedar shake canopy and back lit signage and wall sconces

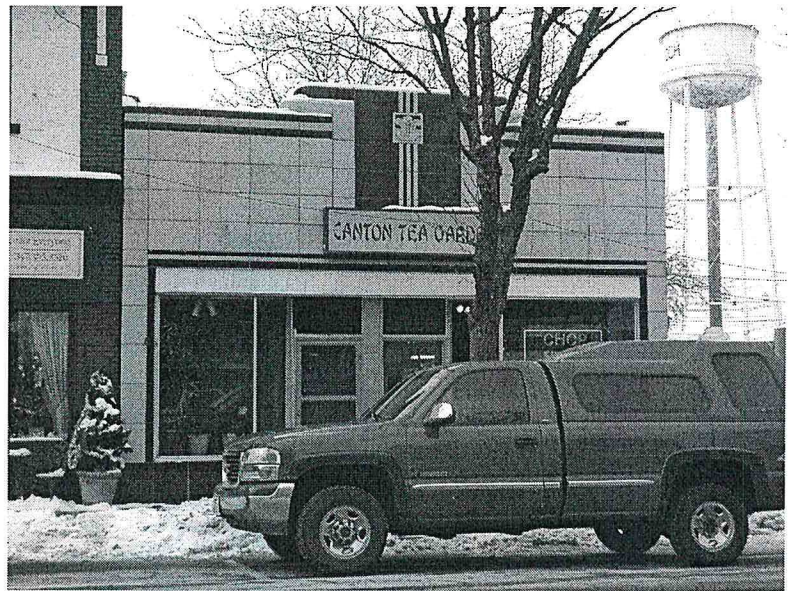
Replacement front doors; vinyl material on frieze above storefronts; replacement windows

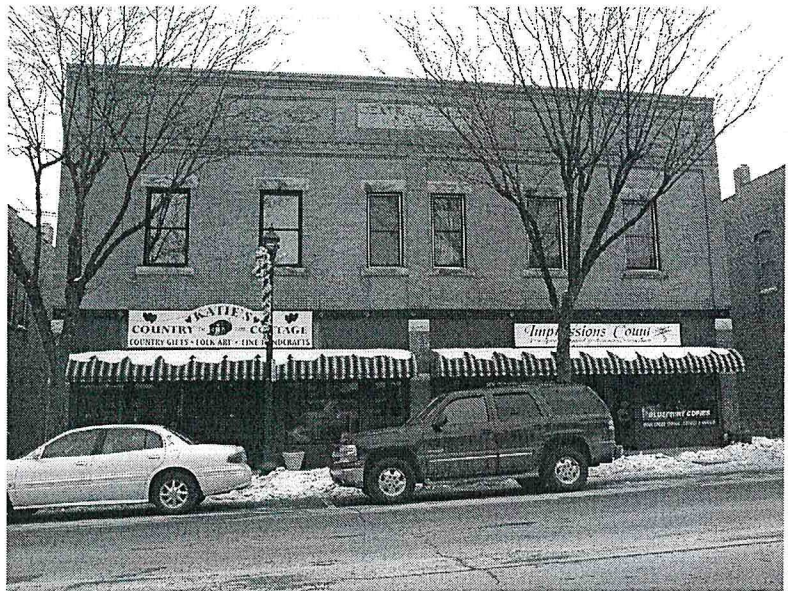
Both storefronts have been reconfigured with non-historic materials including wood vertical board panels over signboard and bulkhead; downsized display windows, and replacement entry doors

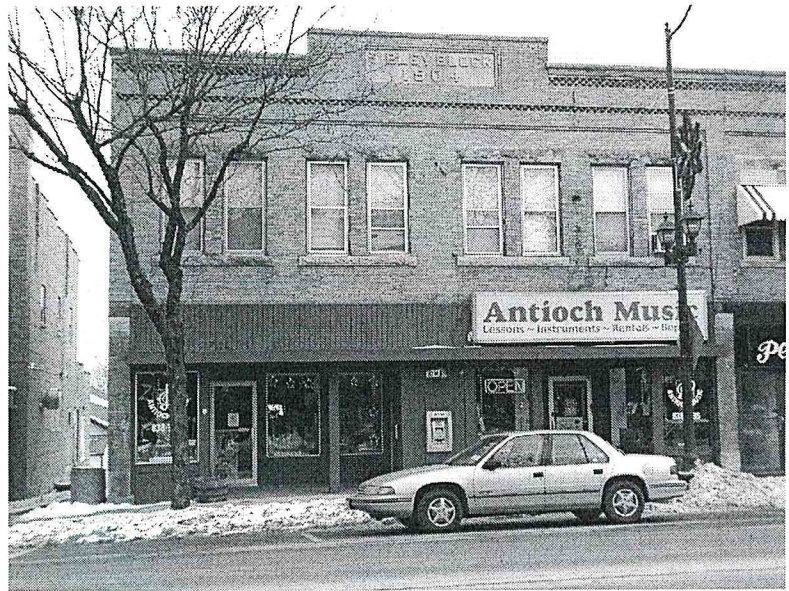
Replacement windows in center and south storefronts; replacement doors in all (configuration has not been altered); Wood sign above north end storefront; lighted sign and paper sign w/ floodlights for center and south storefronts mounted on wood backing; stone veneer below display windows

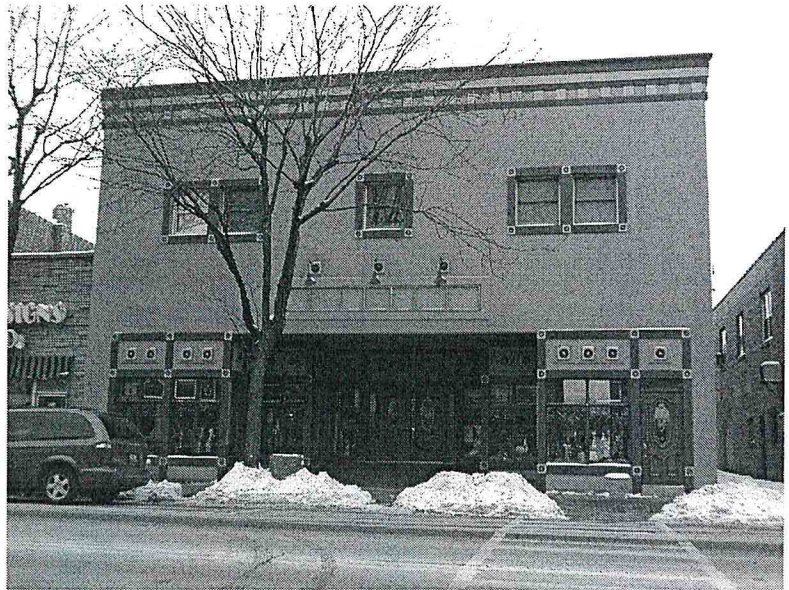
Replacement doors and windows; wood surrounds and bulls eye blocks have been added

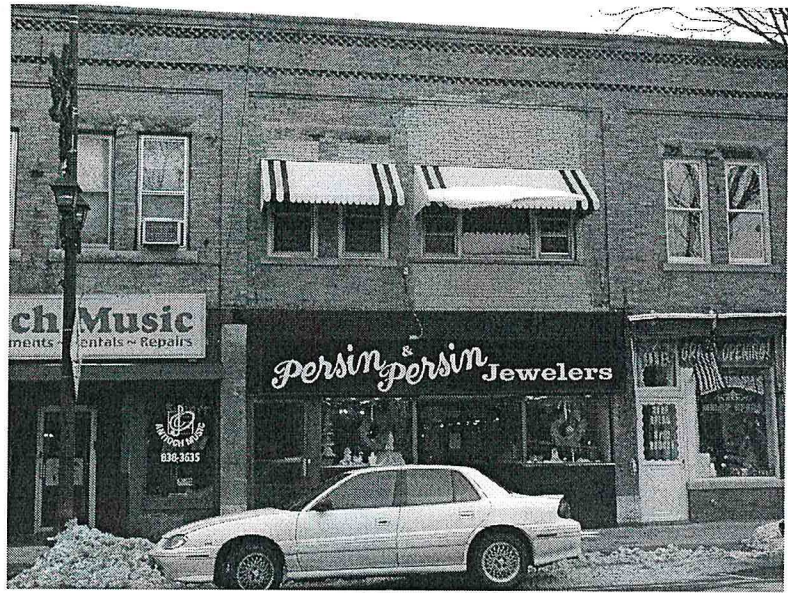
Replacement Aluminum windows and door; altered configuration

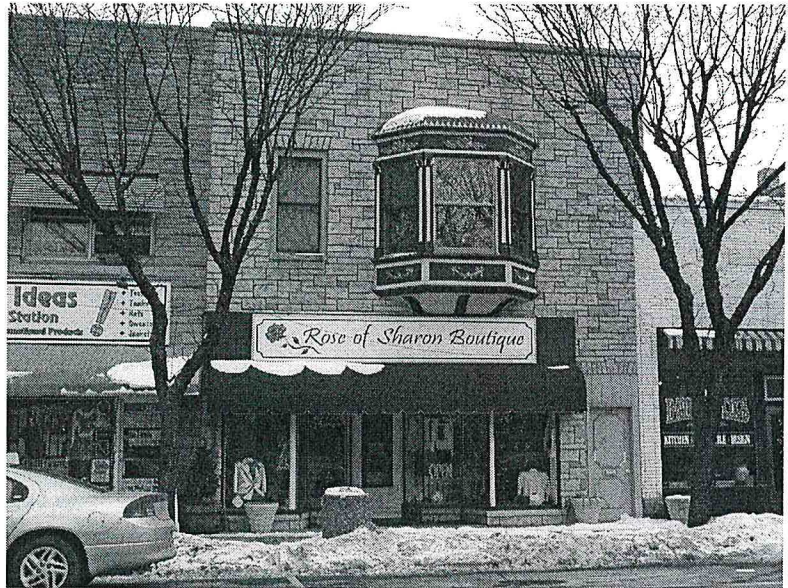
Entire storefront has been reconfigured with replacement materials including plate glass display windows, artificial stone cladding at bulkhead, and wood vertical board at signboard level

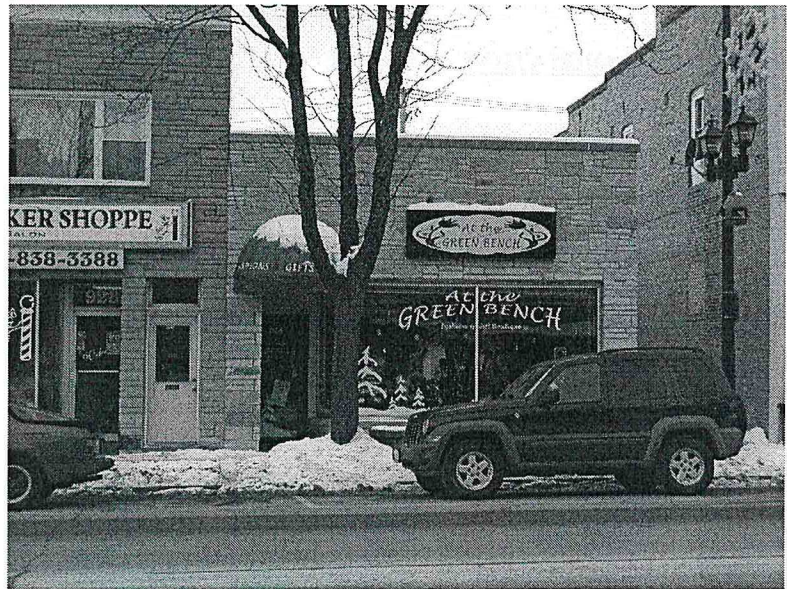
Cloth awning over entry; replacement door in downsized opening; wood sign
